Manhole Inspection Summary

Manhole # S33QQ_005MH

Insp Date: **3/23/07 11:50 AM**

Location Address: **2508 25 1/2th ST**

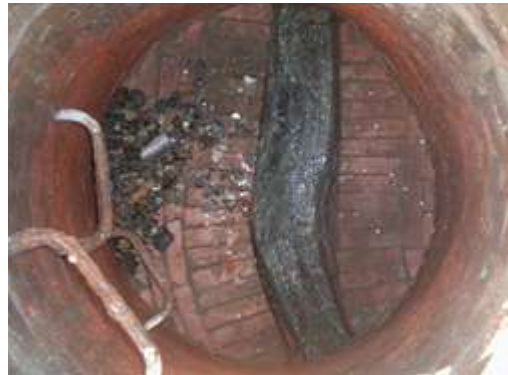
Top View

Bench ☒ Exists Material: **Brick** ☐ Parged ☒ **Debris** (not Condition related)

Steps Count: **3** Missing: **0** ☒ **Corroded**

Corroded steps. Bench debris.

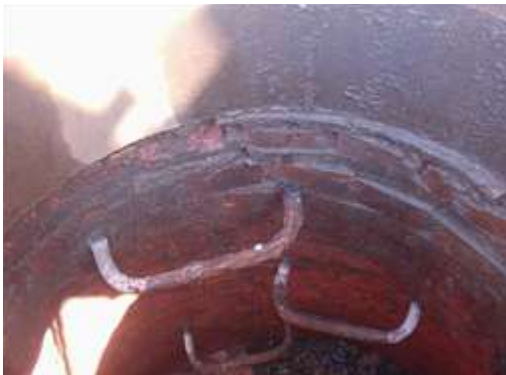
Defect

Frame Offset: **1** (in.) Condition: ☐ Sound ☐ Cracked ☒ **Leaks**

Condition: ☐ Sound ☐ Cracked ☐ Root Intrusion ☐ Loose Brick ☒ **Deteriorated**

Infiltration: ☐ None ☒ **Joint** ☐ Cracks ☒ **Mortar** ☐ Roots ☐ Wall

Frame leaks. Adjustment deterioration and infiltration - other side.

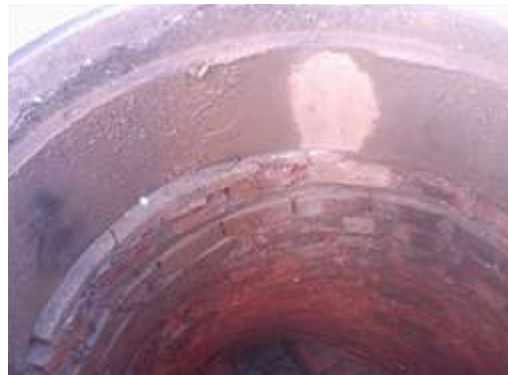
Defect

Frame leaks. Adjustment deterioration and infiltration.

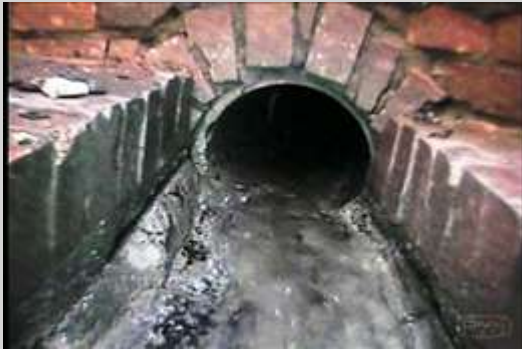
8 in. Circular Gravity Sewer Pipe Out @ 12 O'Clock

Condition: ☐ Sound ☐ Cracked ☐ Root Intrusion ☒ **Deteriorated** ☐ Leaks ☐ Debris

Channel deterioration.

Infiltration: **None** Pipe Seal Cond: **Cracked**
